PERU BOARD OF HEALTH MEETING MINUTES

To: All
From: Bruce Cullett, Selectman
December 28, 2021

Project: Peru Town Hall / Community Center Mold Assessment

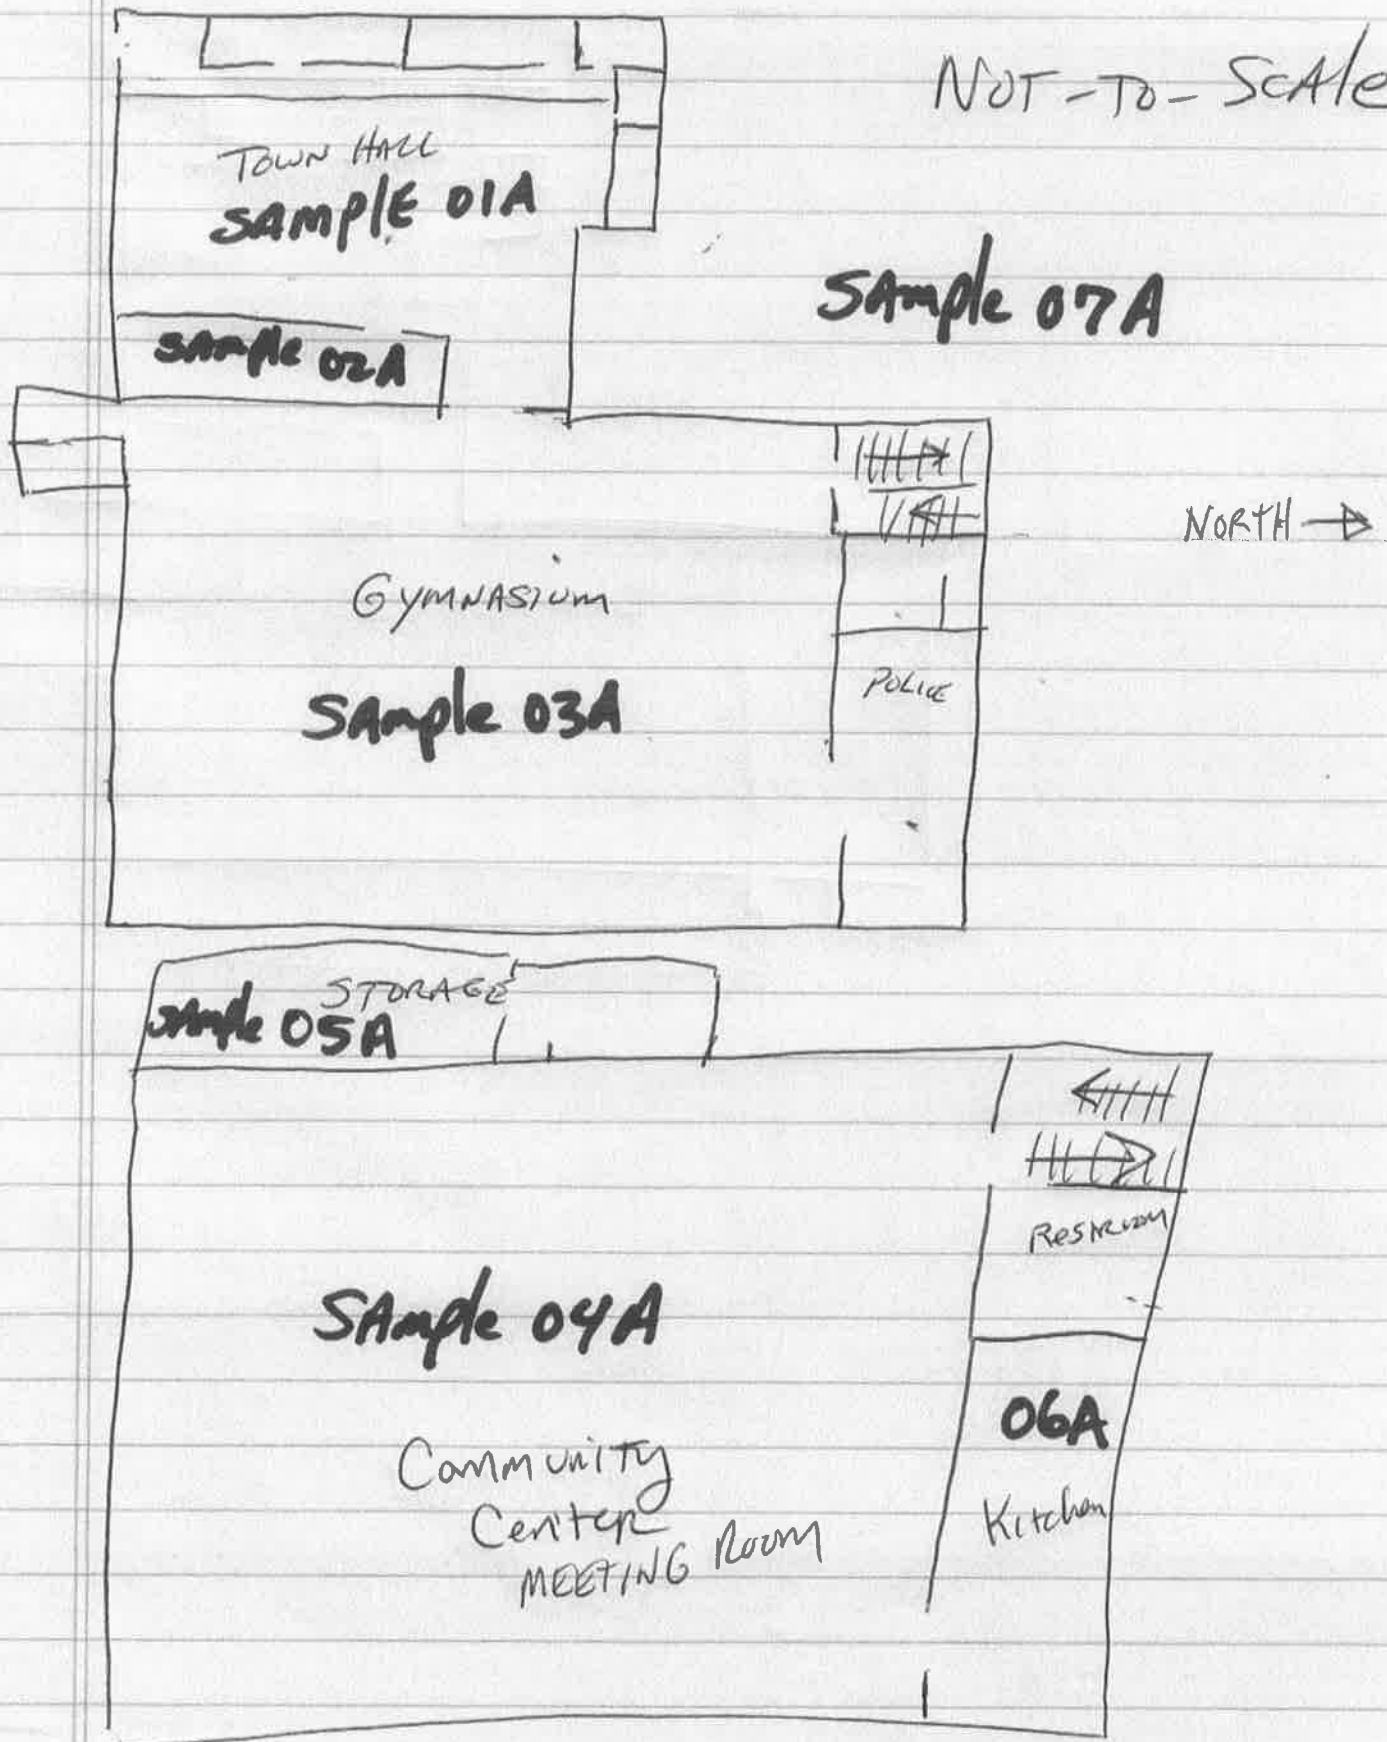
PERU TOWN HALL / COMM
CENTER AIR SAMPLING

Six samples were collected from the interior of the Town Hall/Community Center (see attached sketch) and one sample was collected on the exterior of the building upwind from the building. When evaluating the analytical results, it is important to consider the results of the exterior sample.
